Re: File Closure, Notice of Intent, Dan Shumway, Lucky/Golden Chantz Mine, UTU-68057 (S0370064), Recapture Canyon, San Juan County, Utah

Date: 11/16/09
To: Minerals File UTU-68057
From: Ted McDougall, Geologist
Subject: Surface Management Site Inspection, Dan Shumway, Golden/Lucky Chantz Mine, UTU-68057 (E/037/0064), Recapture Canyon, San Juan County, Utah.

Inspection Report Minerals Regulatory Program April 28, 2010

Mine Name: Golden/Lucky Chance	Permit Number: S/037/0064
Operator Name: Dan Shumway	Inspection Date: April 14, 2010
Inspector(s): T Munson	Time: 4-5 PM
Other Participants: none	Mine Status: regraded

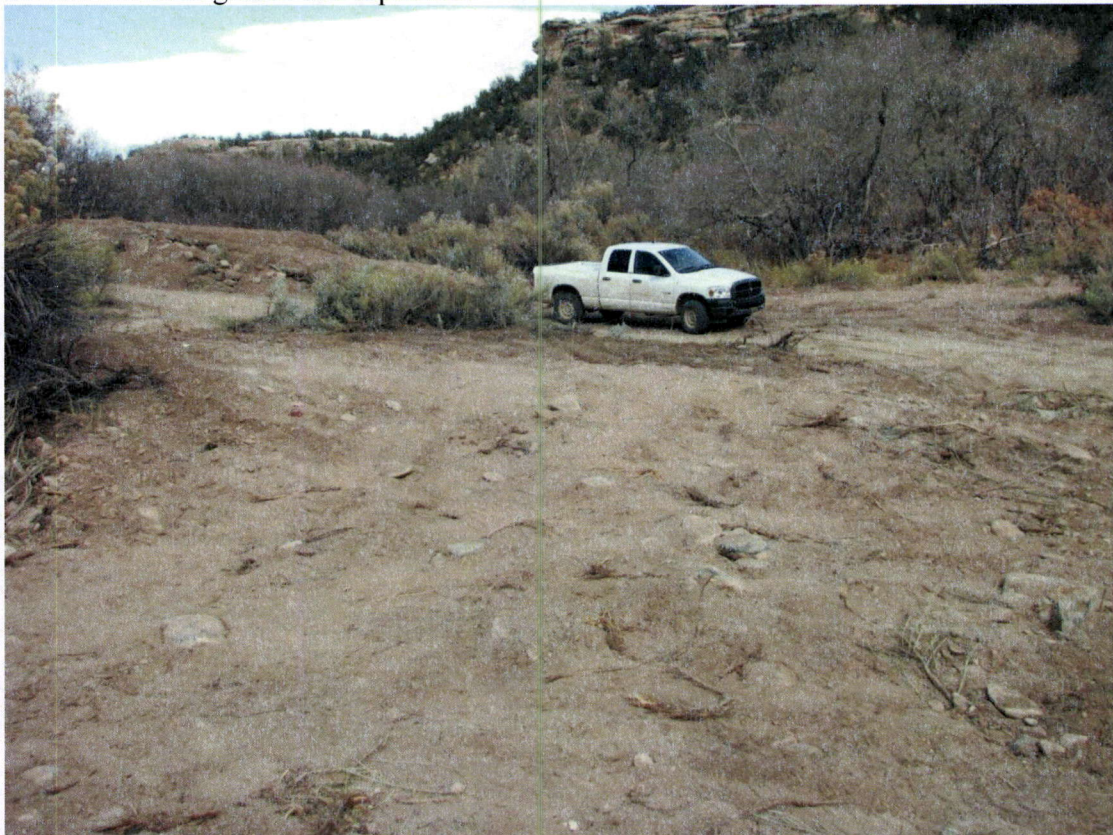
Lucky/Golden Chantz Reclamation. Equipment has been removed from the small site and the site has been graded and topsoiled.
